Performance Optimisation of the Municipal Solid Waste Processing Plant (MSWPP) for Municipal Corporation, Nashik

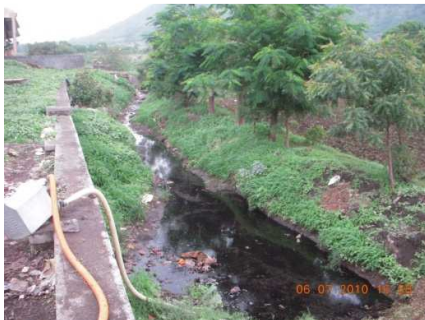
Currently, of the 330 MT of wet mixed waste received daily at the facility, only 13 MTD of compost is manufactured which is about 4% by weight of the input waste. The Inert processing and RDF is still not functional. The sanctioned power is about 600KVA while the total demand applied by NMC is 1100KVA. The biogas generated at the biomethanation facility is used to generate electricity, which in turn is used for powering the captive pumps used for the biomethanation plant. Thus the net electrical balance from the Biomethanation plant is zero. The partially treated water is being discharged into the nallah outside the plant.

Partially treated water discharge

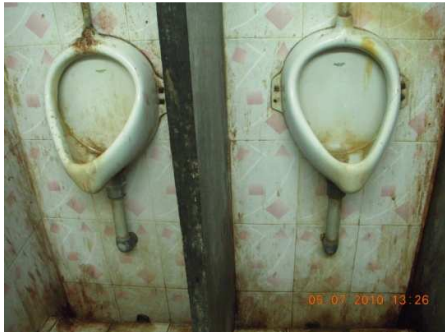
The administration/ office building is not properly maintained and shows accumulation of scarp and dirt in nooks and corners. The Toilets and urinals are very dirty and unhygienic. The toilets doors and flush tanks need replacement.

Unclean Urinals

1. Cleaning of overhead water tank,
2. Cleaning Toilets and bathrooms, defective toilet door replacement
3. Installation of Reverse Osmosis Water supply

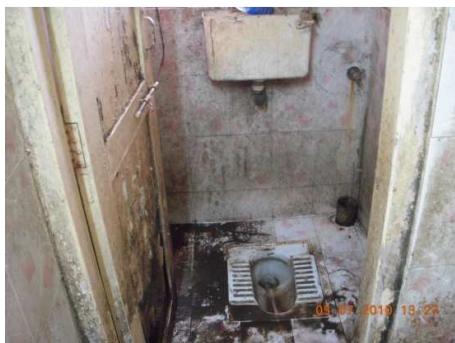
Dirty Toilet

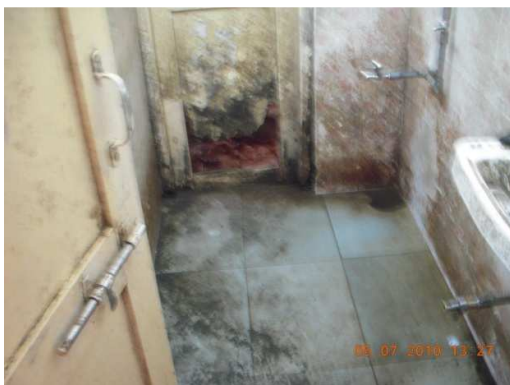
Broken Toilet door

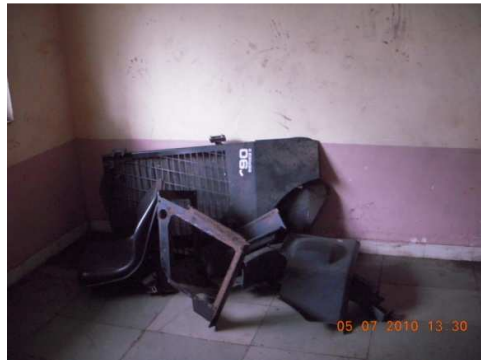
Metal scrap lying at present

1. Landscaping- Primarily lawn, flowering plants and aromatic plants to be grown.
2. All metal scrap, pipes, truss materials, excess liner materials, engine blocks, cans etc to be shifted to a designated place and not littered within the premise

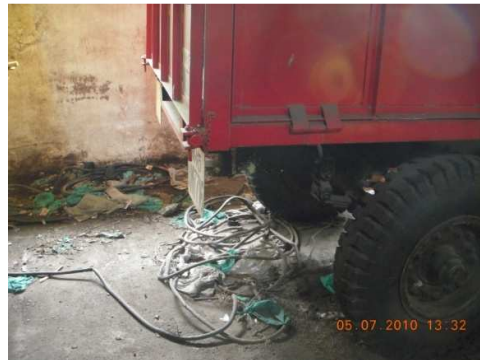
Scrap littered in the premises at present

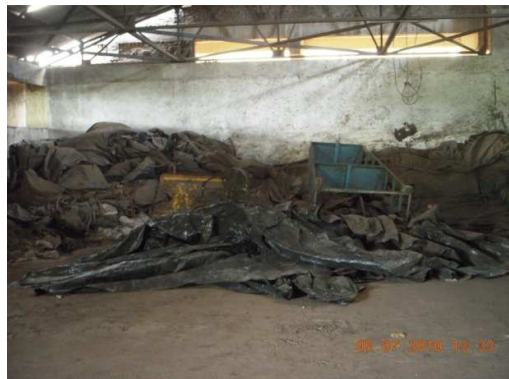
Excess liner material lying in the premises

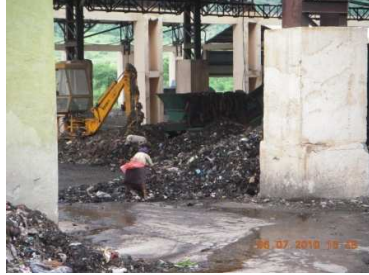
3. All the open drains, pipe culverts should be cleared of garbage, so that water may drain freely and should be cleared after every shift
4. All access roads to be swept after every shift
5. External vehicles including garbage carrying trucks should not enter the waste processing area like windrow yard, trommel etc. This will reduce the need for frequent road sweeping
6. Ragpickers should not be allowed inside the processing plant
Ragpicker picking up the waste at present

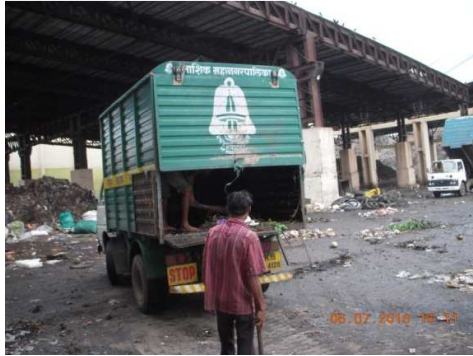
Person working without using PPEs at present

4. Providing a dedicated clean and well ventilated lunch and rest room for workers
5. It should be made mandatory for each worker to wear personal protective equipments like mask, gloves, gum boots and Uniforms

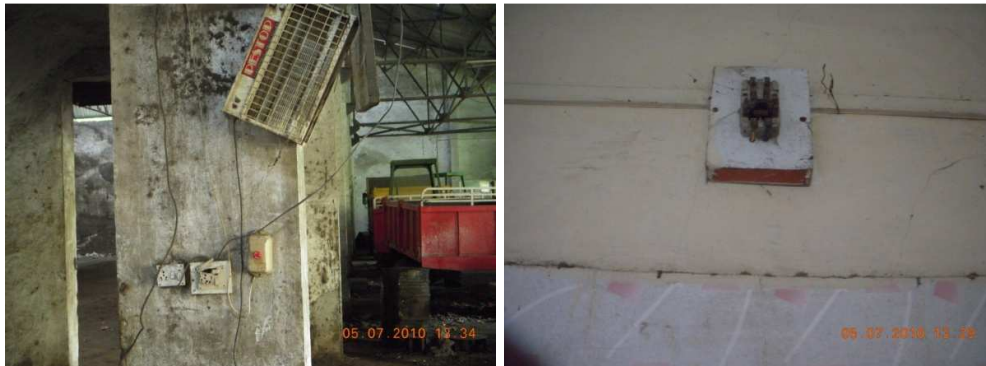
It has been observed that all the panels are covered with dust which can cause electrical hazard. All the light fittings are also covered with dust. Live electrical starters were found lying on ground. The lubricant and hydraulic oil were also noticed on cables and panels. The following actions are required

1. Panel rooms to be cleaned and glass barrier to be provided to prevent dust entry
Broken and dusty electrical panel and switch

2. Individual panel boards, starters to be checked and securely fixed. Leaking hoses to be tightened, replaced
3. Wirings and terminations to be checked and secured
4. Emergency stops should be provided for all equipments
5. Electrical and Fire safety equipments to be provided in the plant.
6. Hooter system to be provided for alerting personnel

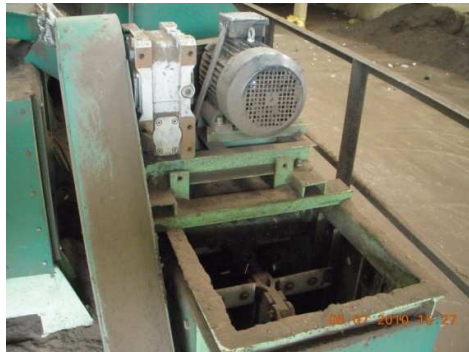
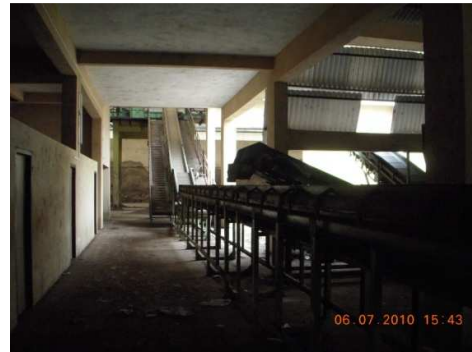
Dust accumulation on the existing equipments

1. The electrical contractor engaged by NMC has been requested to furnish the "As built drawing" for the electrical works such as equipment cabling, machinery wiring etc. He has been asked to make appropriate modification so that "Electrical Interlocks" are provided. The interlock would ensure that in case of shutdown of any particular equipment, all equipments before it would stop automatically. At present, this is not the case.
2. Side guards with flexible materials should be fitted to prevent dust exposure to the chain drives.

3. Required lubricants to be used as per schedule to be intimated by the Operation manager
4. Equipment supplier “Monica” or any other may be called to offer quote for refurbishing of the old equipments. This will ensure that we have redundancy to take up peak loads

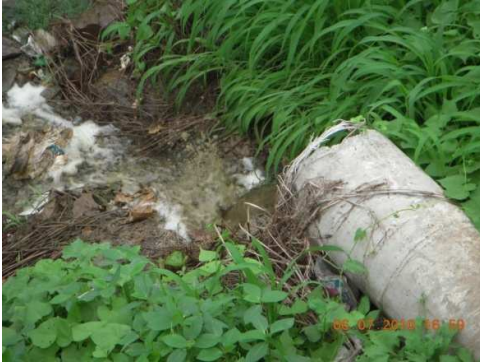
The open drain from dump site is discharging leachate into open nallah which is currently being pumped to the biomethanation plant. Leachate is mixing with surface water and the hydraulic load on the Biomethanation has increased, resulting in lower HRT.

Discharge of untreated leachate

Therefore the treatment of water is also affected and thereby contaminating the nearby ground. The process water from windrow platform is flowing all over the yard as the drain is choked. The actions required are

1. Diverting the dump site leachate into the biomethanation plant
2. Constructing a sump near the windrow yard for collecting process water for reuse in the windrow composting
